nationalgrid	ELECTRIC OPERATING PROCEDURE TRANSMISSION AND Sub TRANSMISSION	Doc. # NG EOP T007.02
	Aerial Visual Inspection	Page 1 of 9 Version 1.0 – 06/01/15

This document provides the details for performing the Aerial Visual Inspections of National Grid Transmission and Sub-Transmission assets. The procedure shall be executed by Qualified Personnel as determined by training specific to the task.

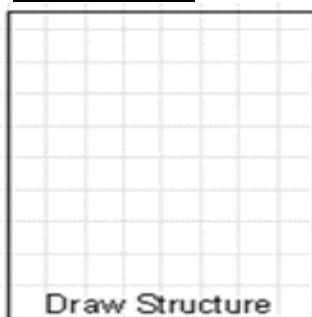
Appendix A - Aerial Visual Inspection Worksheet

Aerial Visual Inspection Worksheet						
Line #						
Str #	Notes:					
Avian	Pole	Crossarm	Structure	Conductor	Insulator	ROW
Nests	Crack/Rot	Crack/Rot	Damage	Birdcaged	Broken	Encroachment
Perching	Burned	Broken	Rust	Broken	Flashed	Tree
Other	Leaning	Other	Bent	Sag	Not Plumb	Other
	Woodpecker		Leaning	Other	Hardware	
	Other		Other		Other

<p>Draw Structure</p>

- 2.1 If the hand-held data recording device is not used during the aerial inspection, documentation shall occur as follows:
 - 2.1.1 Defects shall be documented using the Transmission Aerial Survey Worksheet.

- a. Appendix A
 - 2.1.2 The inspection deficiency codes and grading levels may be determined later.
 - 2.1.3 Comments and/or pictures shall be descriptive enough to enter the appropriate code and grading level into the transmission MMS database.

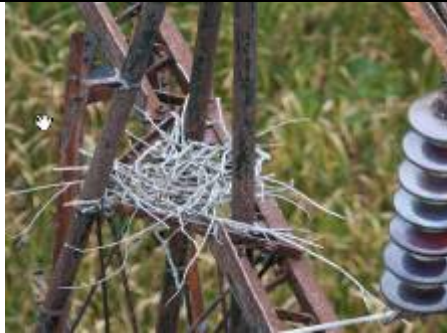
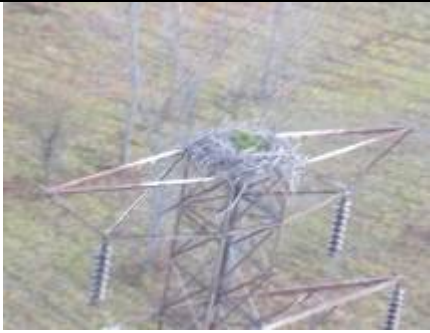
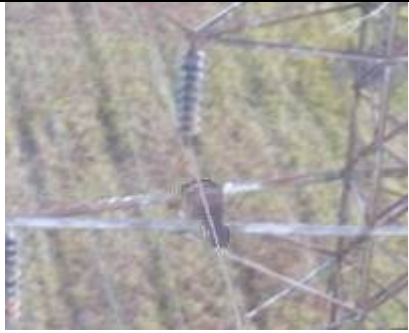
AVIAN

Nests	Nests	Perching

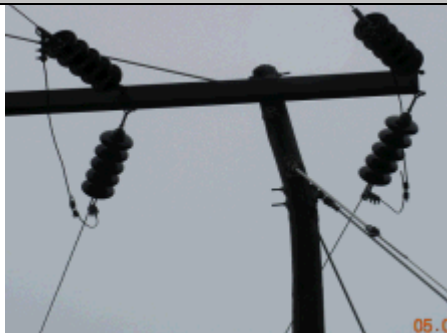
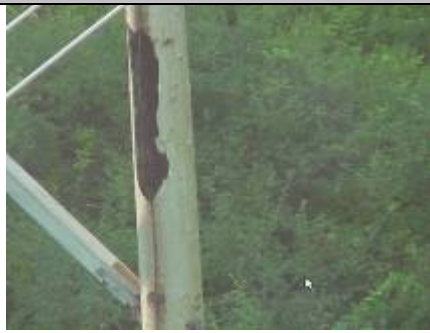
Poles

Broken structure members	Burned pole top	Burned pole top.

- a. Inspect for:
 1. Broken Pole
 2. Burning Pole
 3. Rotting Pole
 4. Woodpecker Damage
 5. Leaning Pole
 6. Lightning Damage

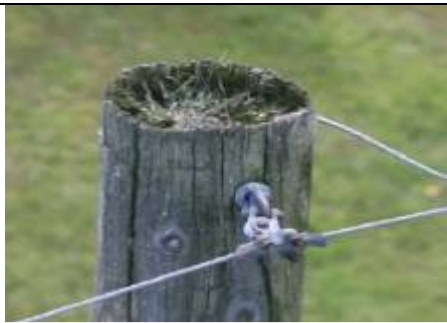
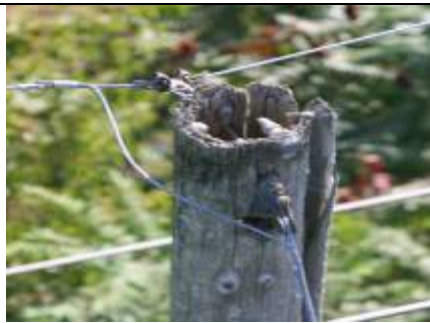
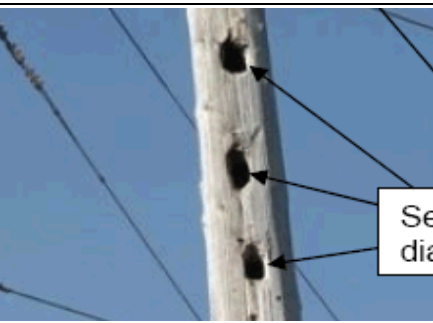
Rotted w/vegetation in pole top.	Rotted pole top.	Woodpecker damage

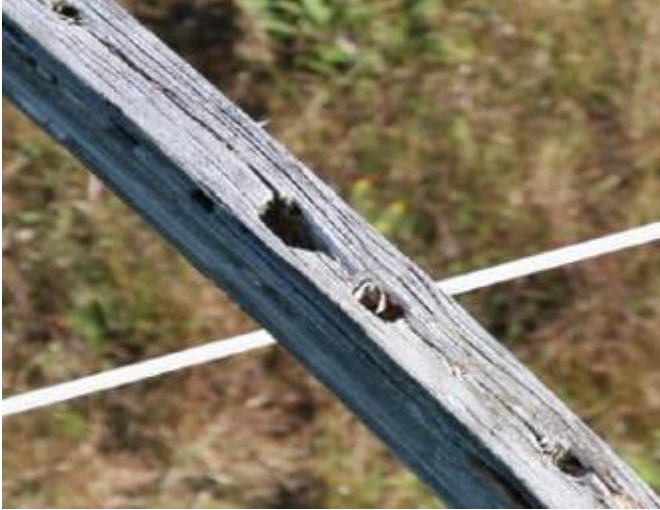
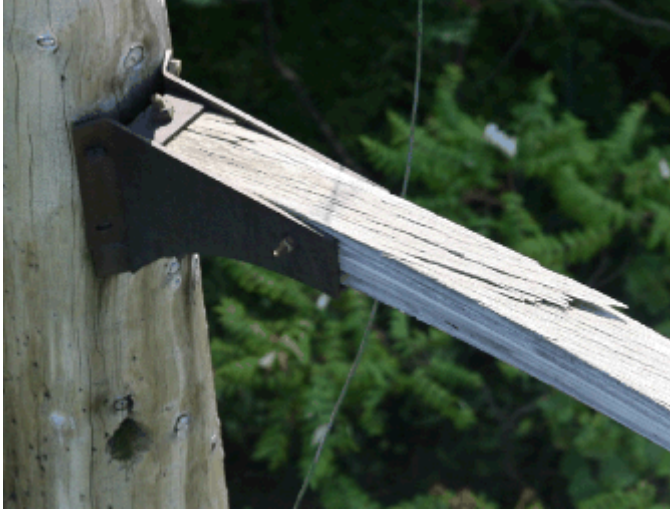
Crossarm

Cracks/Woodpecker holes	Cracks	
STRUCTURE

- a. Inspect for:
 - 1. Broken Arm
 - 2. Cracked Arm
 - 3. Rotted Arm

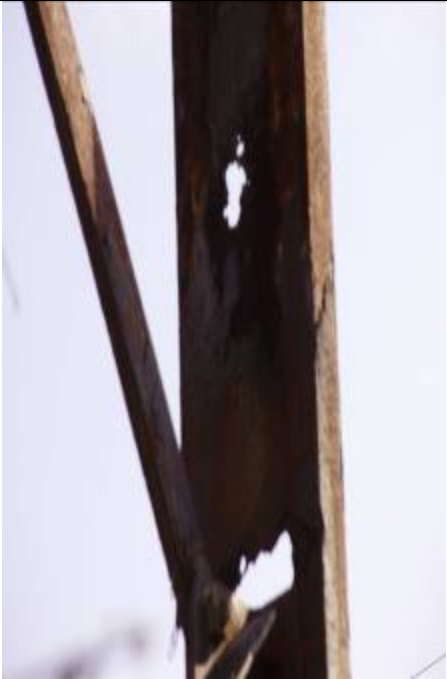
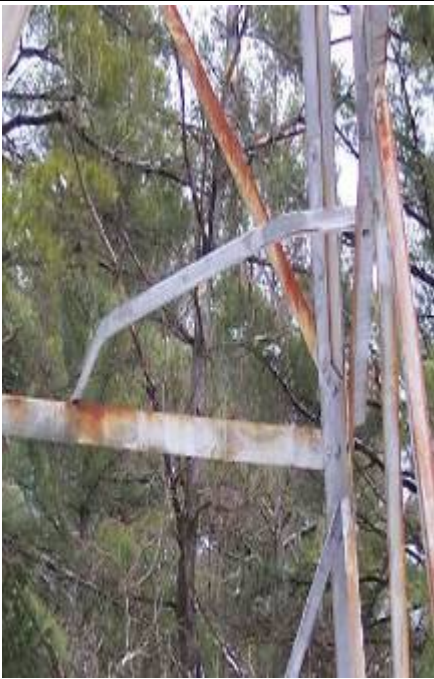
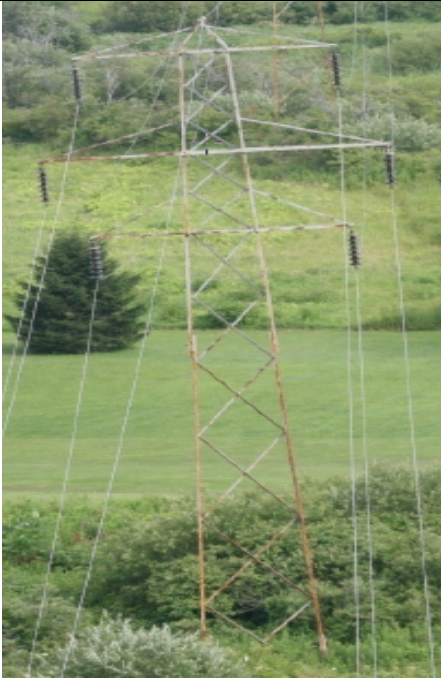
Rusted steel	Bent/deflected steel	Leaning

- a. Inspect for:
 - 1. Damaged Steel
 - 2. Rusted Steel
 - 3. Bent or Deflected Steel
 - 4. Leaning Structure

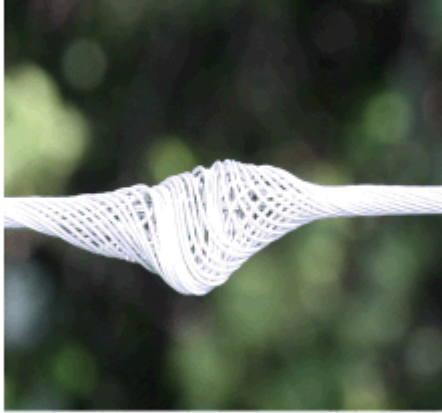
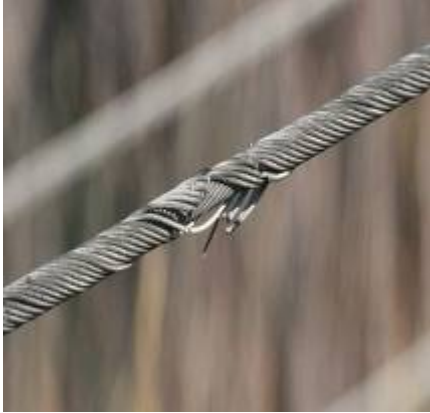
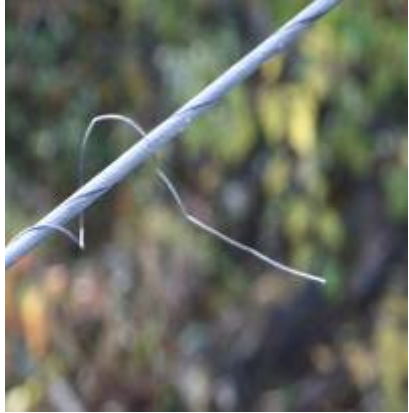
CONDUCTOR

Bird Caging	Broken Strands	Broken Strands

- a. Inspect for:
 - 1. Bird Caging
 - 2. Broken Strands
 - 3. Sag Issues
 - 4. Tree Clearance Issues

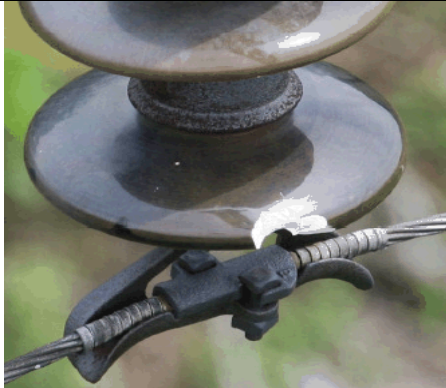
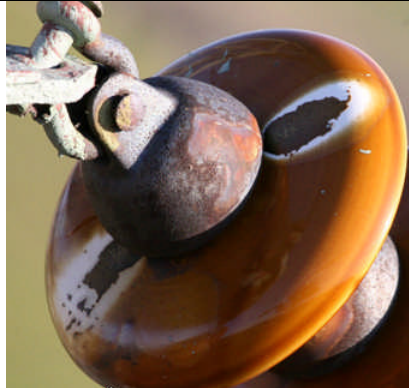
INSULATORS

Broken	Broken	Flashed

- a. Inspect for:
 - 1. Broken insulators
 - i. List quantity broken and total in string
 - 2. Flashed insulators
 - i. List quantity flashed and total in string
 - 3. Out of plumb insulators
 - 4. Hardware problems
- b. Table 2 shall be used as to determine the reporting level for the number of defective insulators in a string:

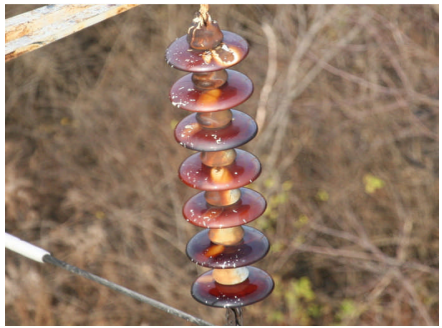
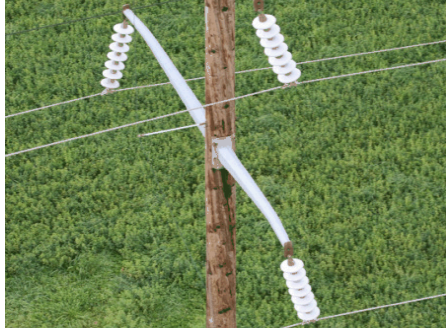
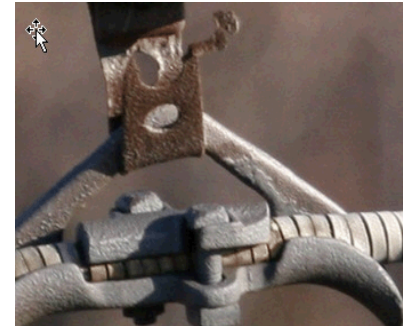
Flashed	Out Of Alignment	Hardware Problem

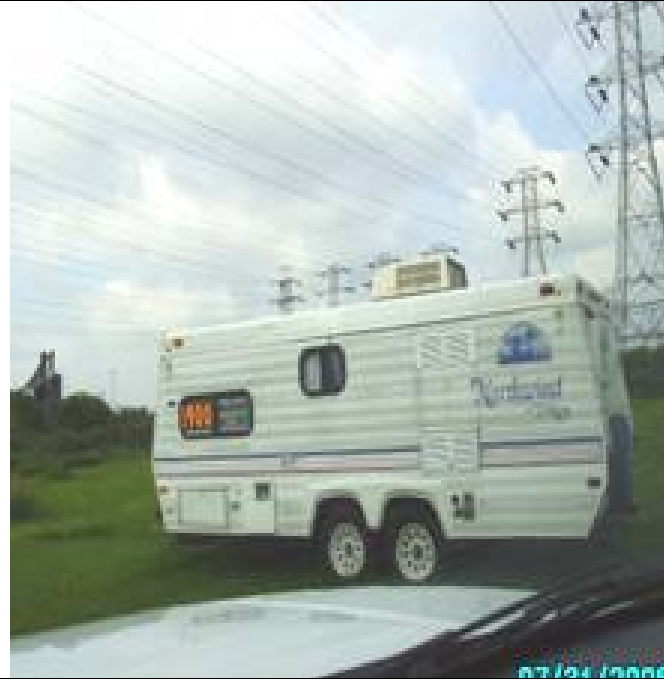
ROW ISSUES

Encroachments

- a. Broken or flashed insulators
- b. Leaning or damaged structures
- c. Broken hardware
- d. Damaged or broken conductors
- e. Tree conditions
- f. ROW encroachment, erosion or damage
- g. Conductor clearance problems
